# THE VANGUARD SATELLITE LAUNCHING VEHICLE - AN ENGINEERING SUMMARY \*

(Engineering Report No. 11022)

April 1960

THE MARTIN COMPANY, Baltimore, Md.

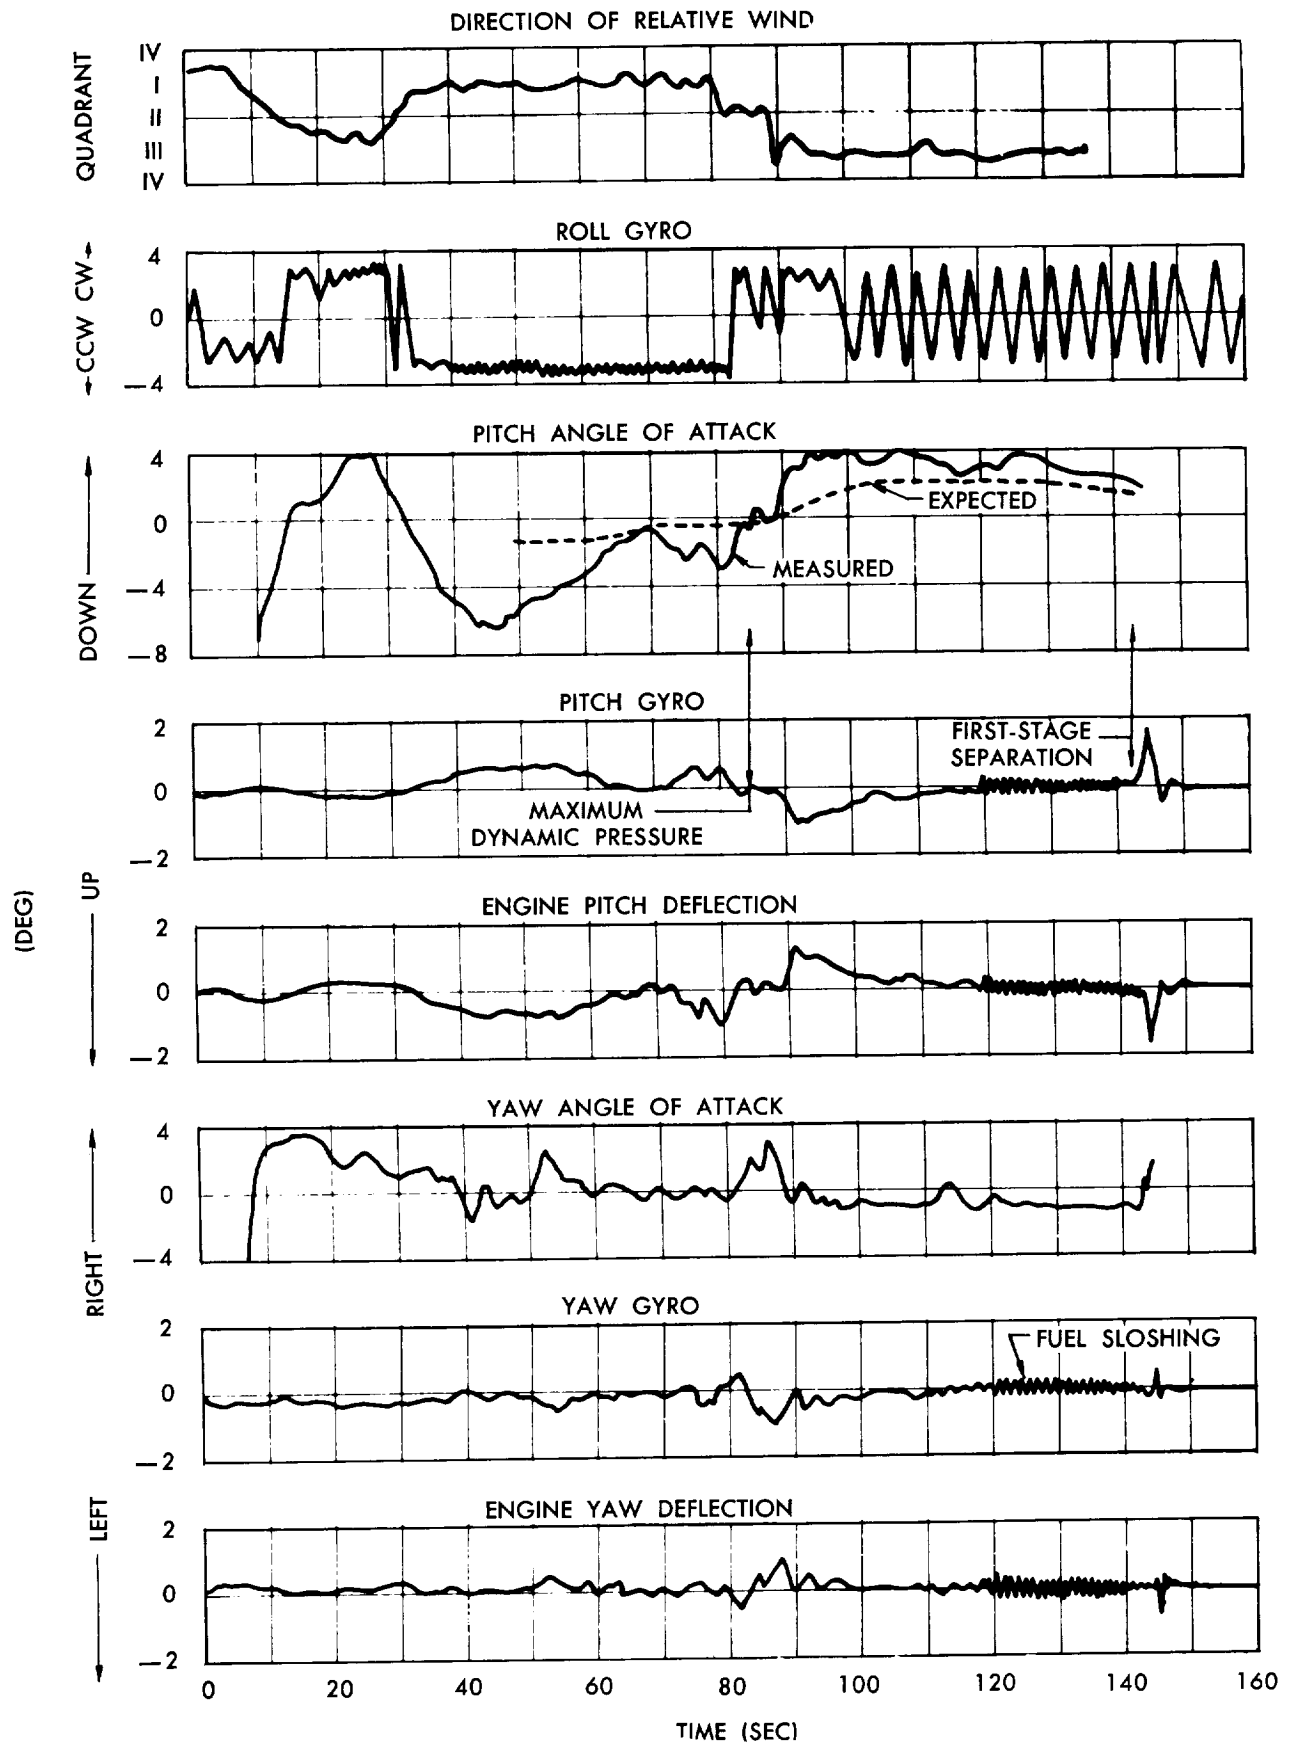
Fig. 48 Typical Angle of Attack, Vehicle Motions and Controls Reactions During First-Stage Powered Flight

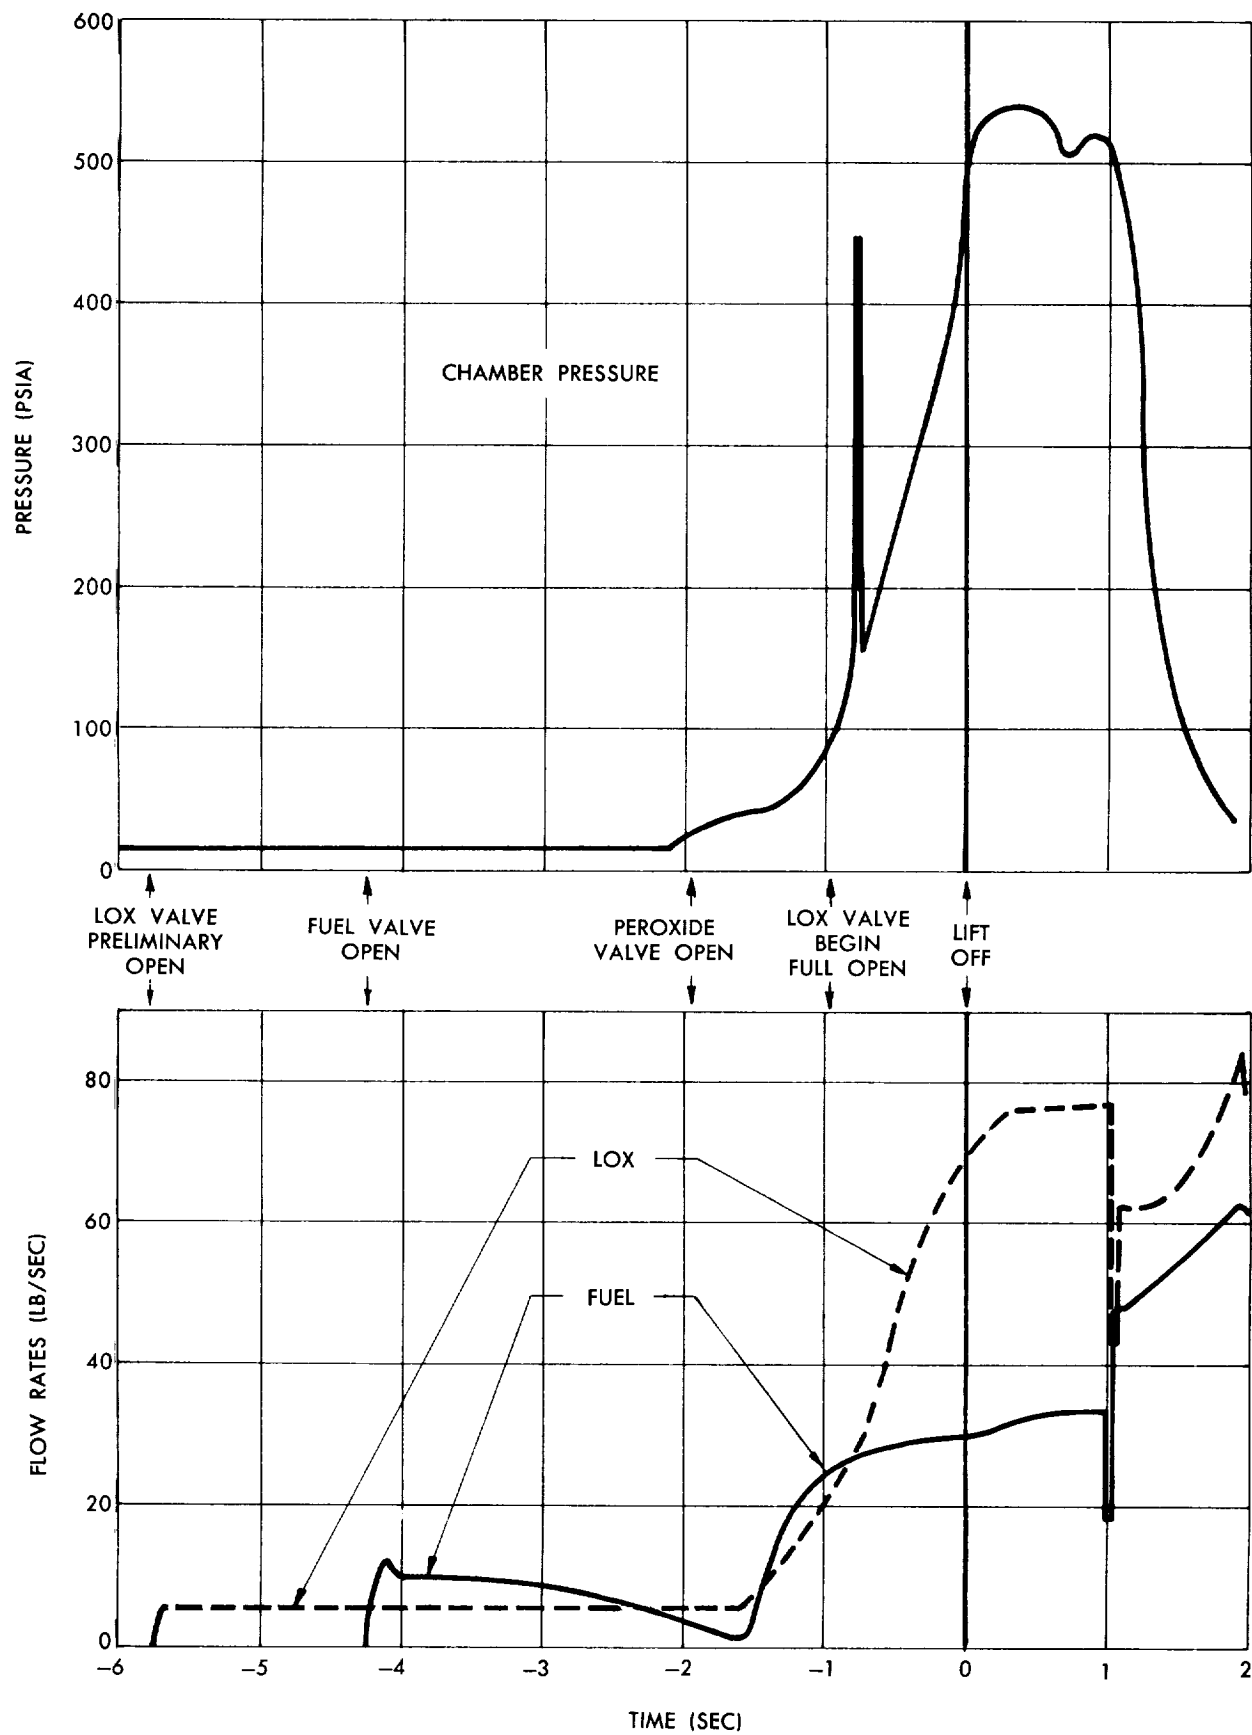
Fig. 49 Time History of Chamber Pressure and flow rates During TV-3 First-Stage Starting Transients

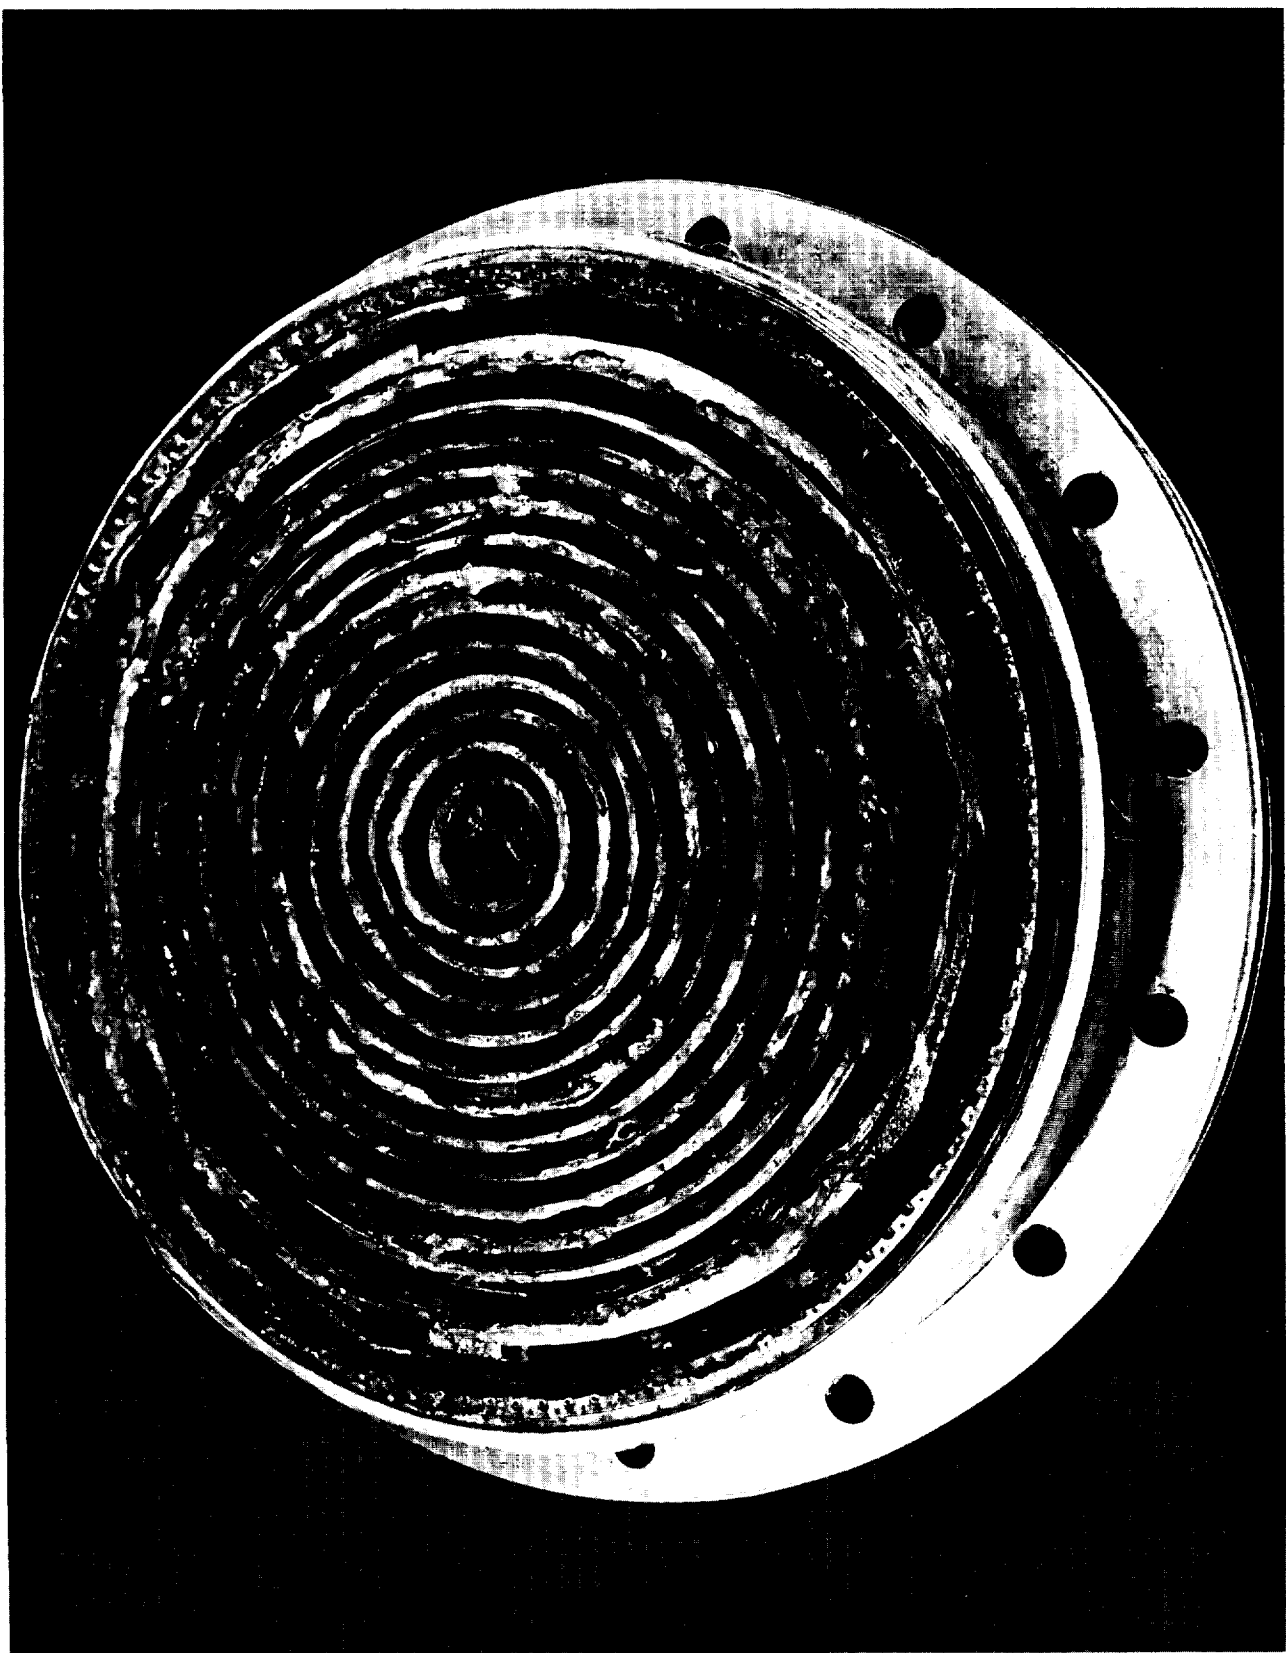
**Fig. 50 The First-Stage Injector After the Flight Firing of TV-3**

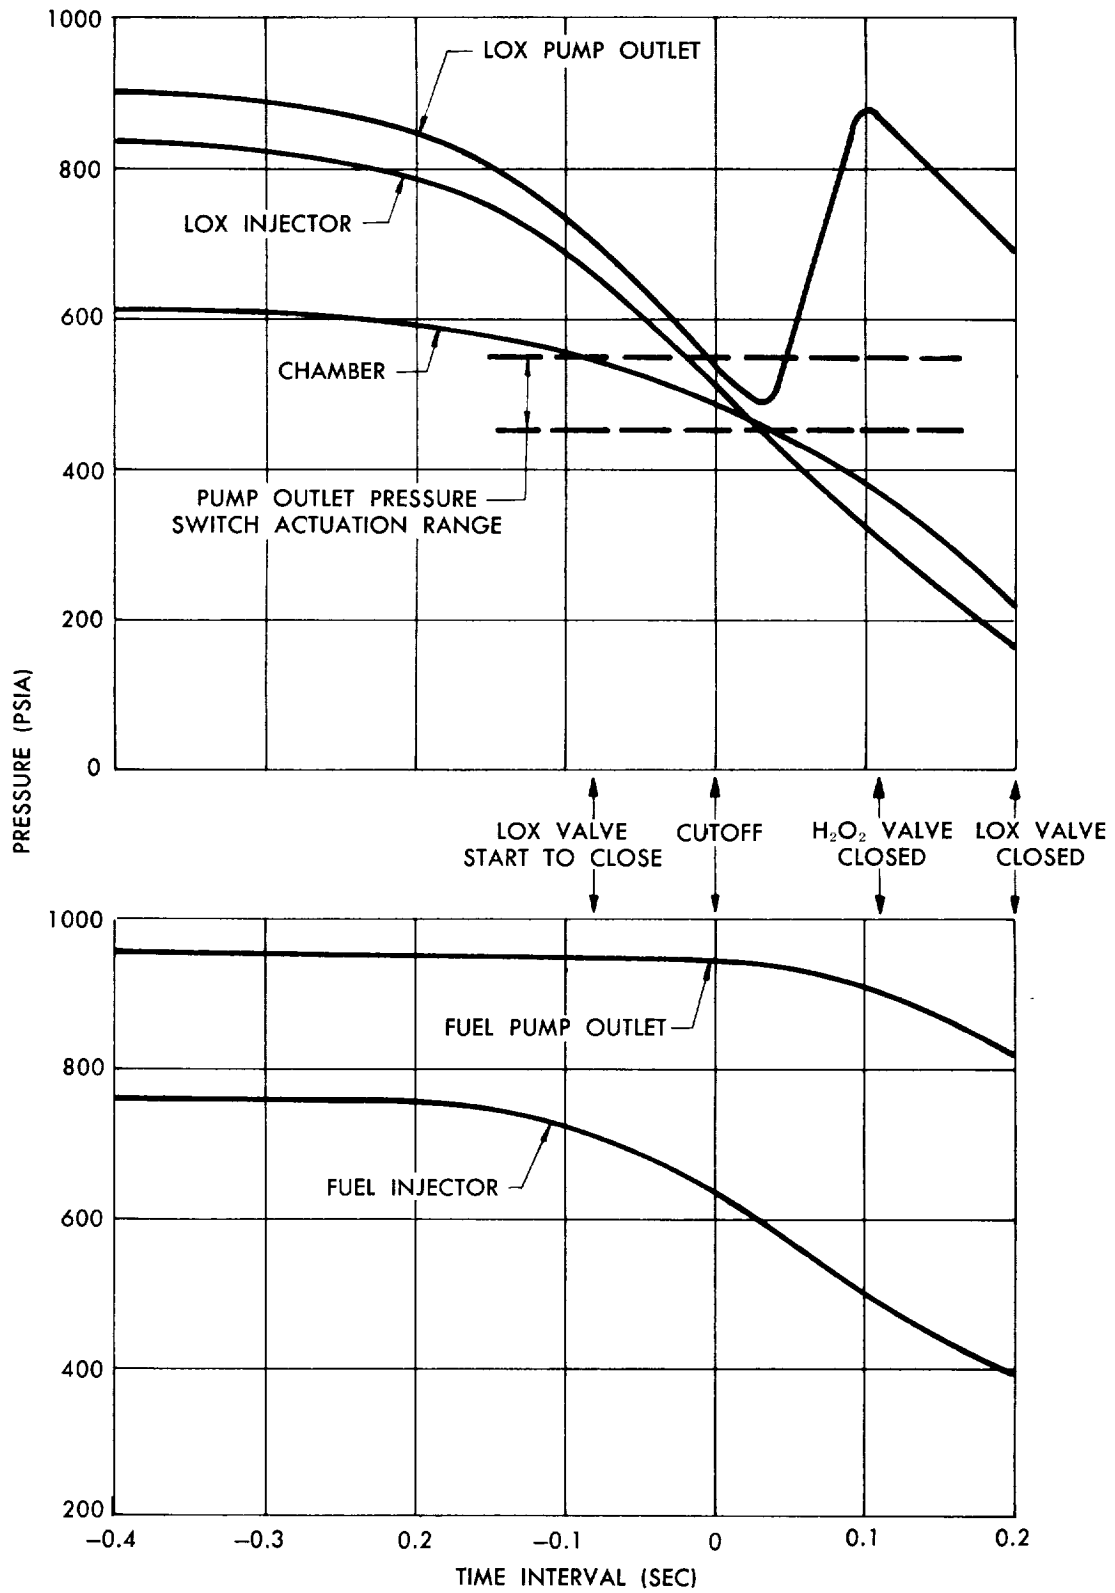
Fig. 51 Typical First-Stage LOX Exhaustion Shut-down Transient

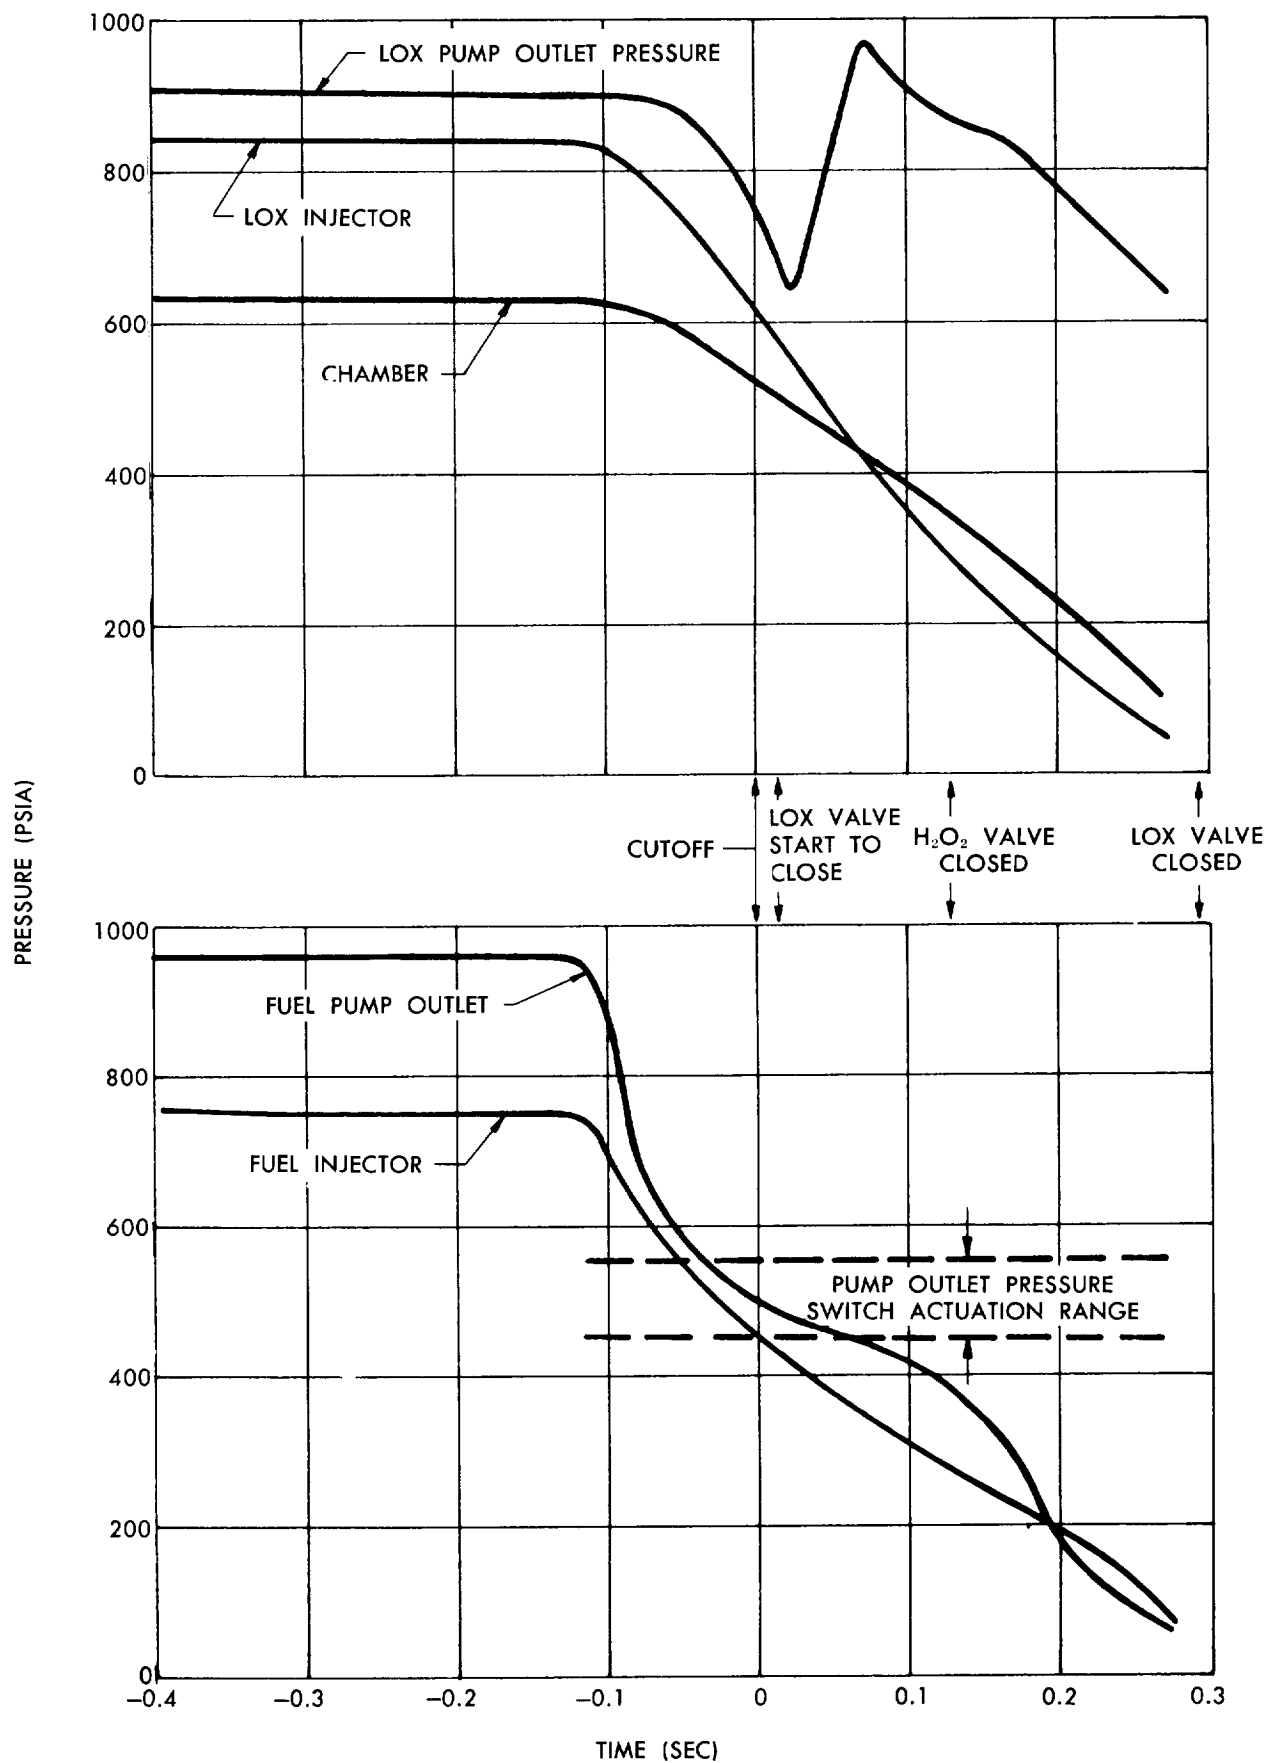
Fig. 52 Typical First-Stage Fuel Exhaustion Shut-down Transient

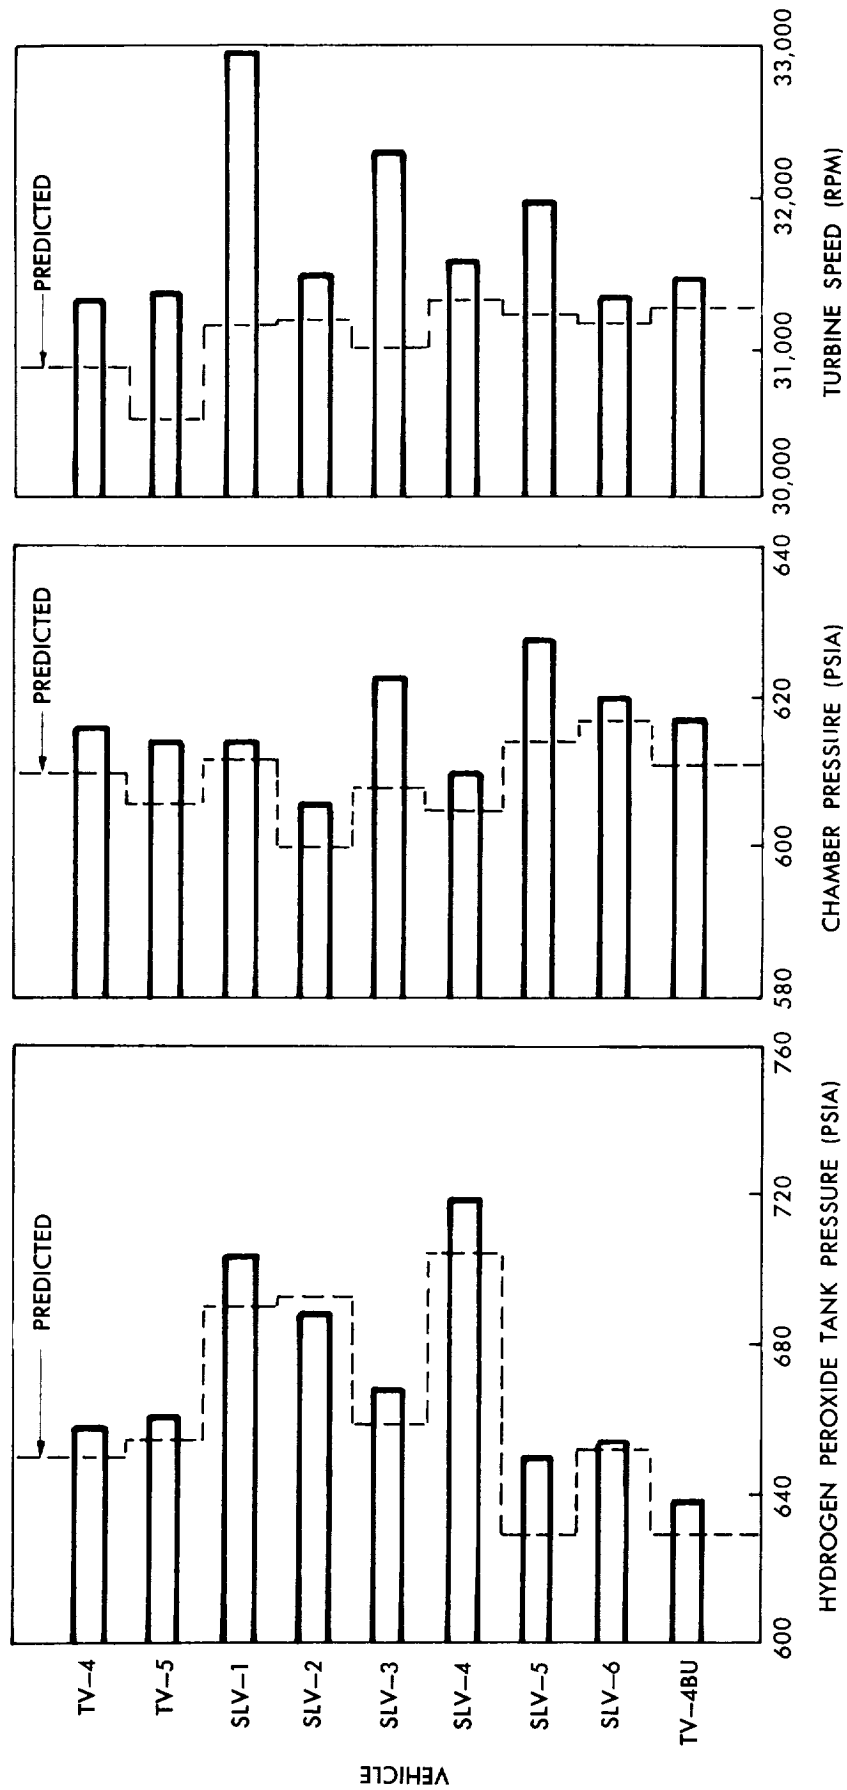
Fig. 53 First-Stage Hydrogen Peroxide System Parameters

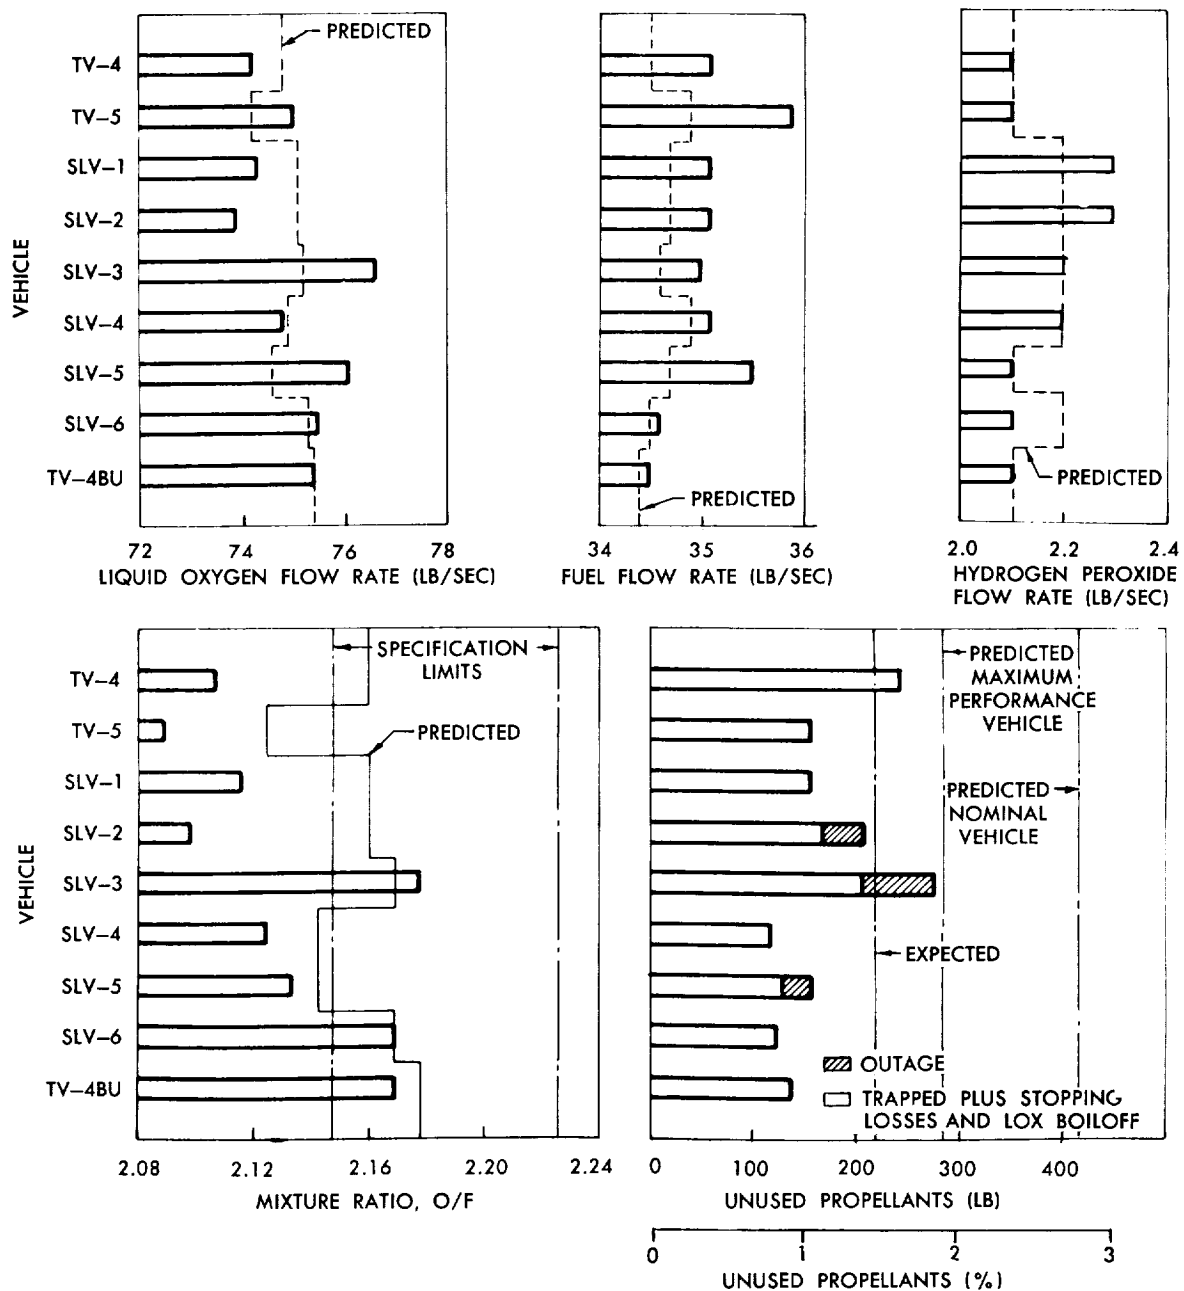
**Fig. 54 First-Stage Propellant Parameters**

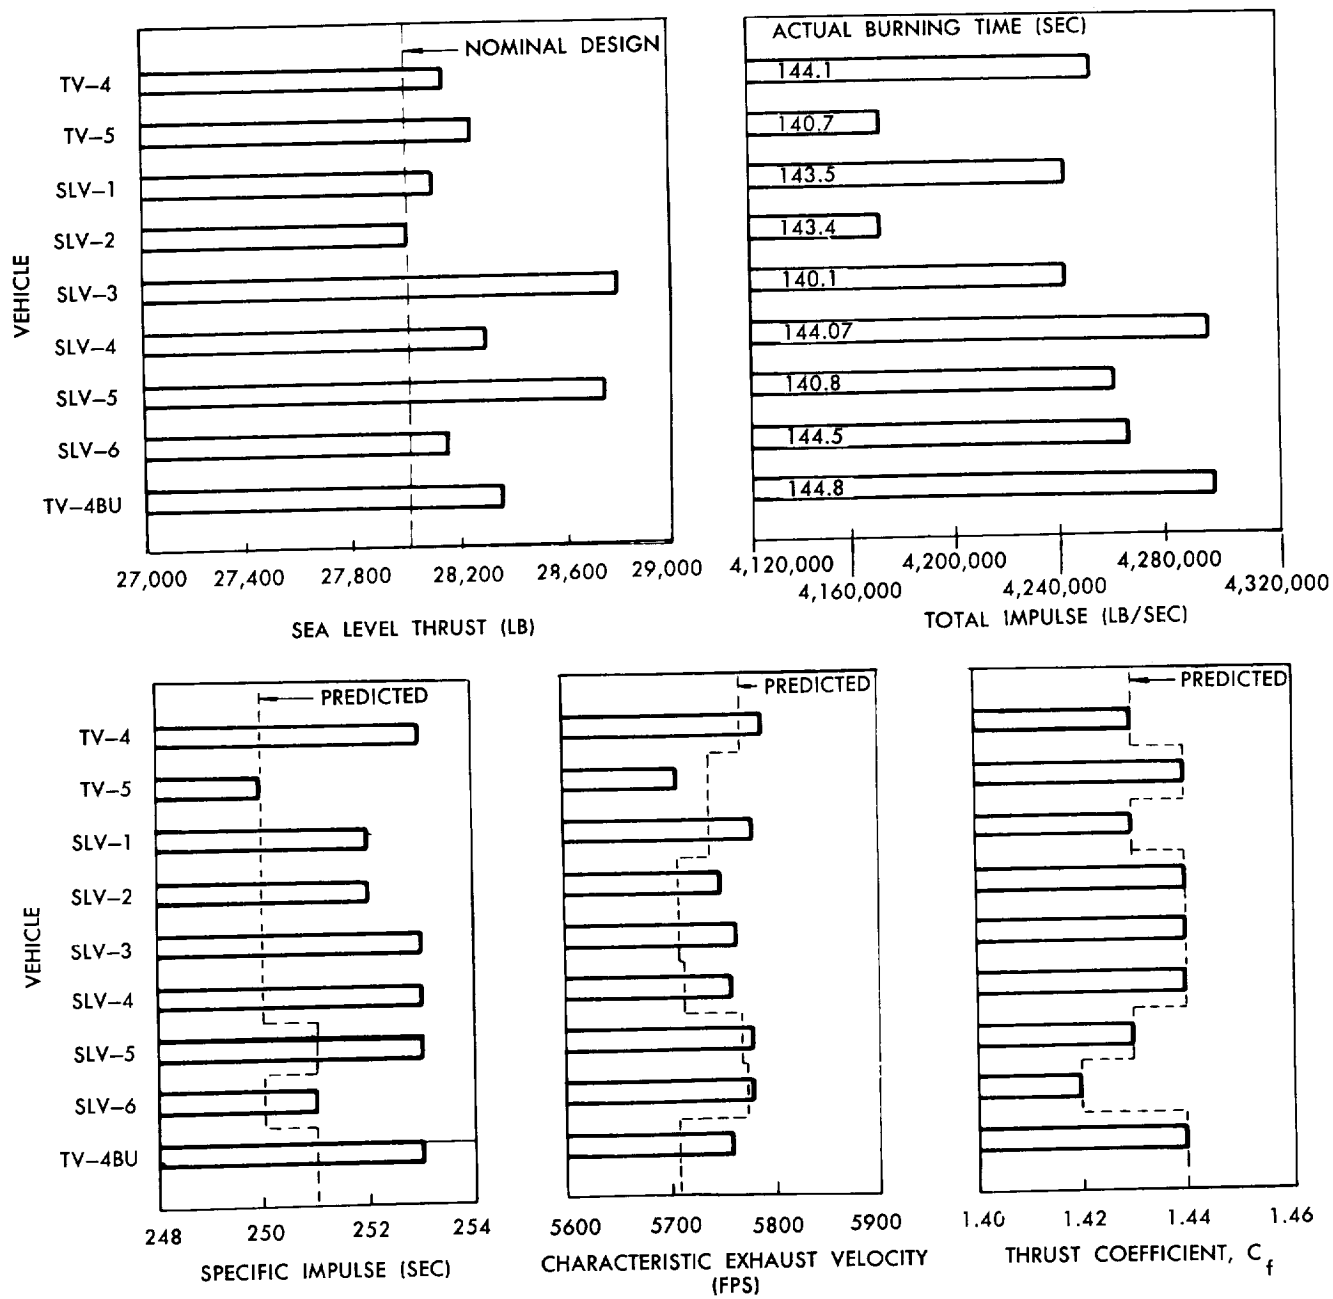
Fig. 55 First-Stage Performance Parameters

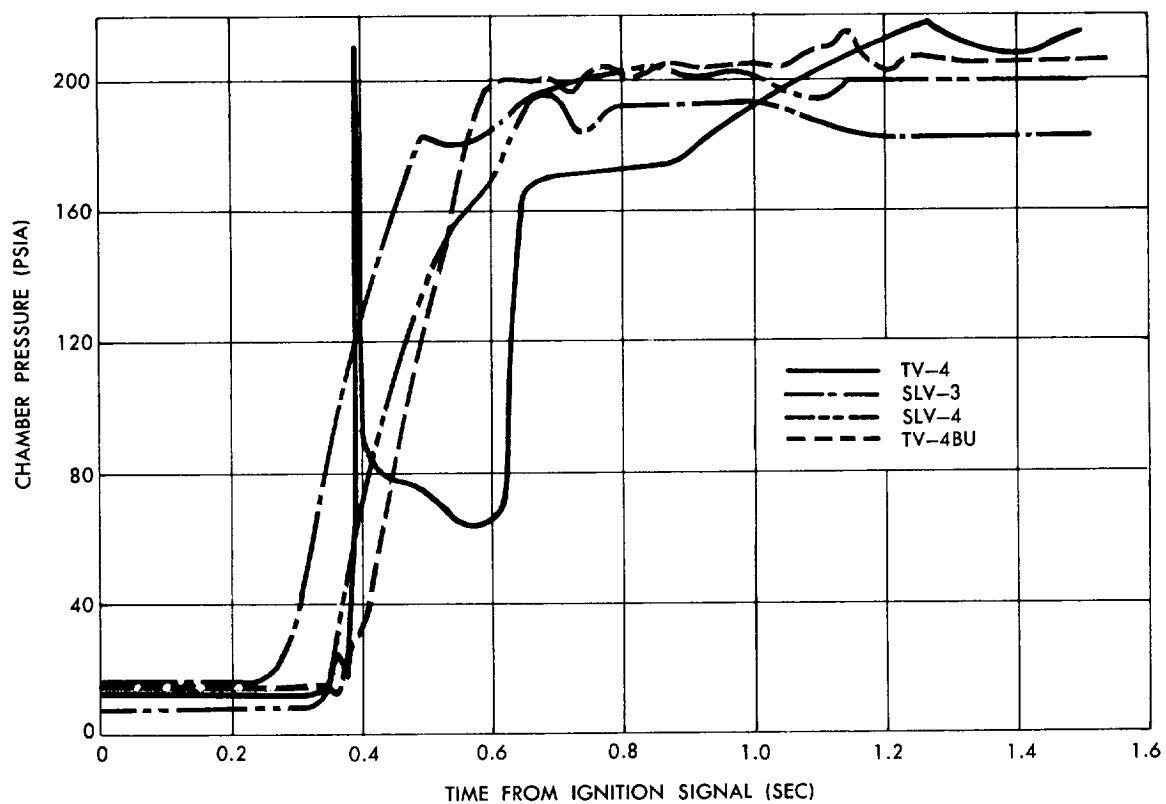
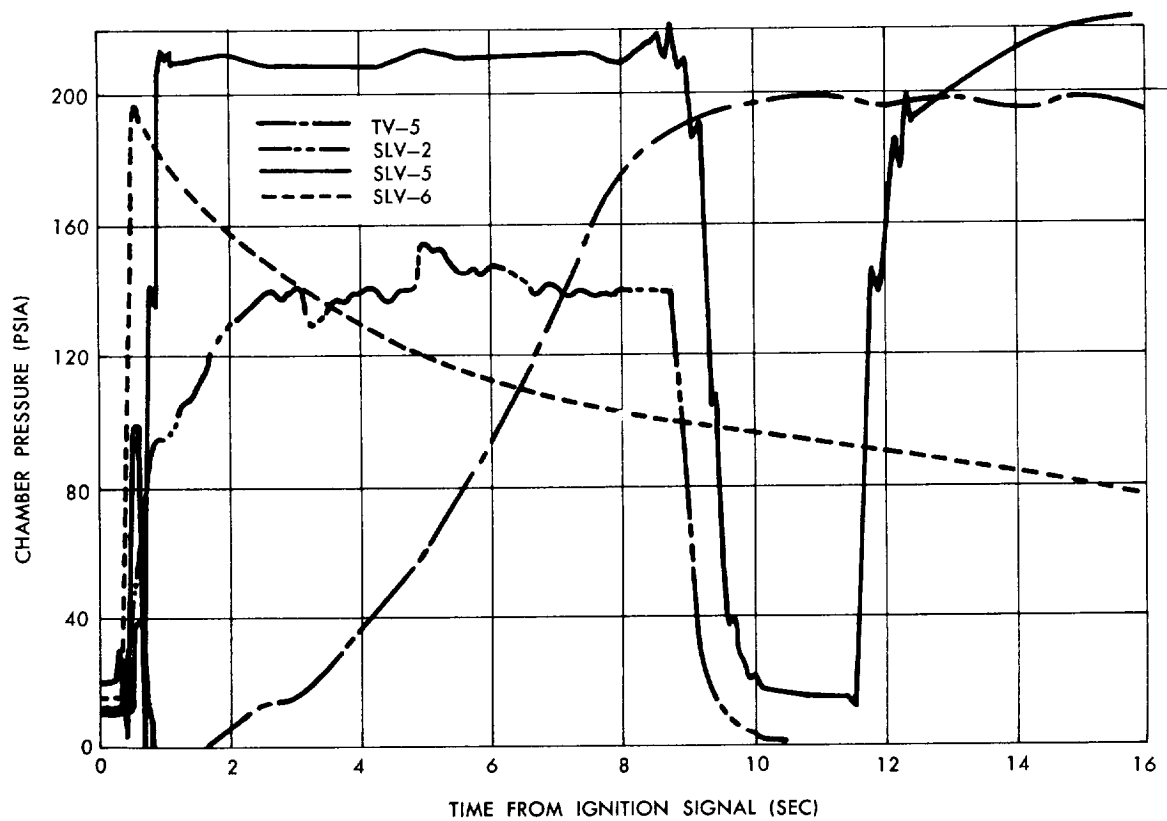
**Fig. 56 Time Histories of Second-Stage Chamber Pressure During Starting Transient**

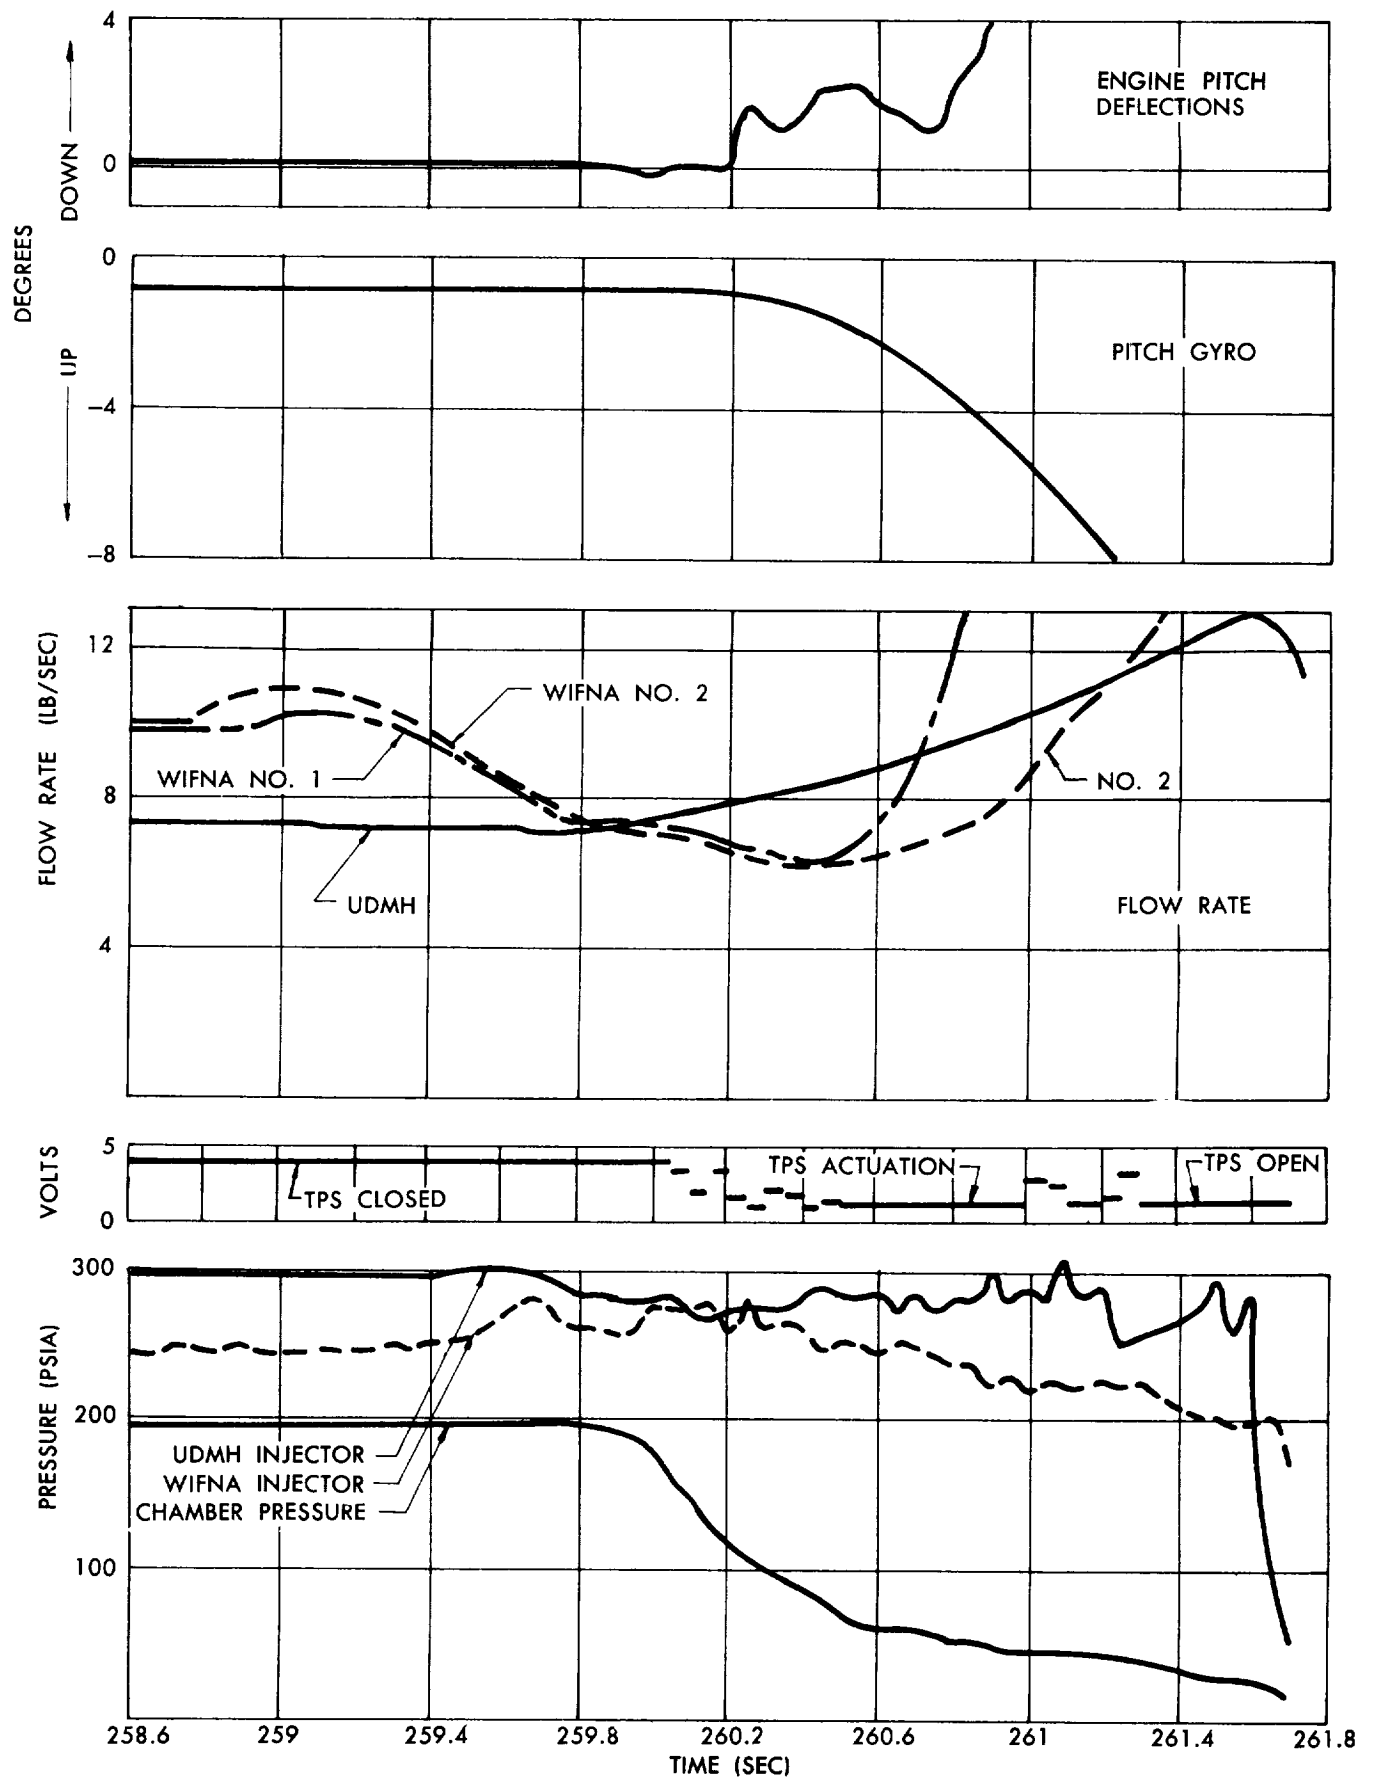
Fig. 57 Time History of SLV-1 Second-Stage Shut-down Transients

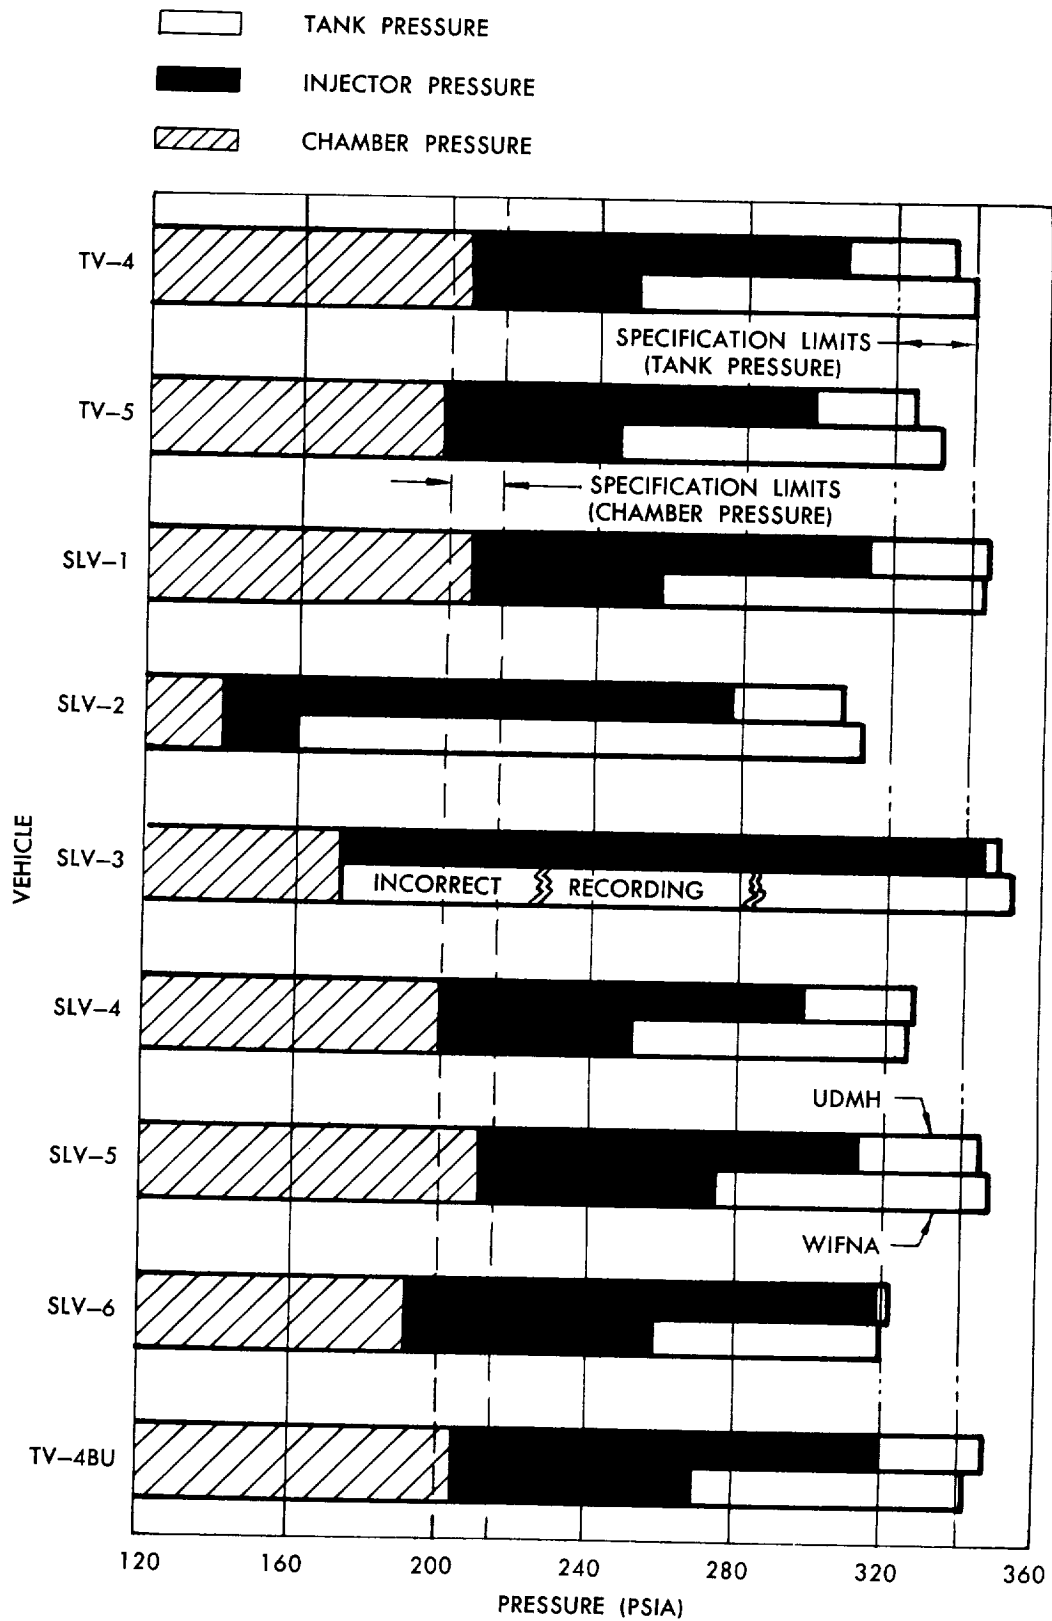
Fig. 58 Second-Stage System Pressures

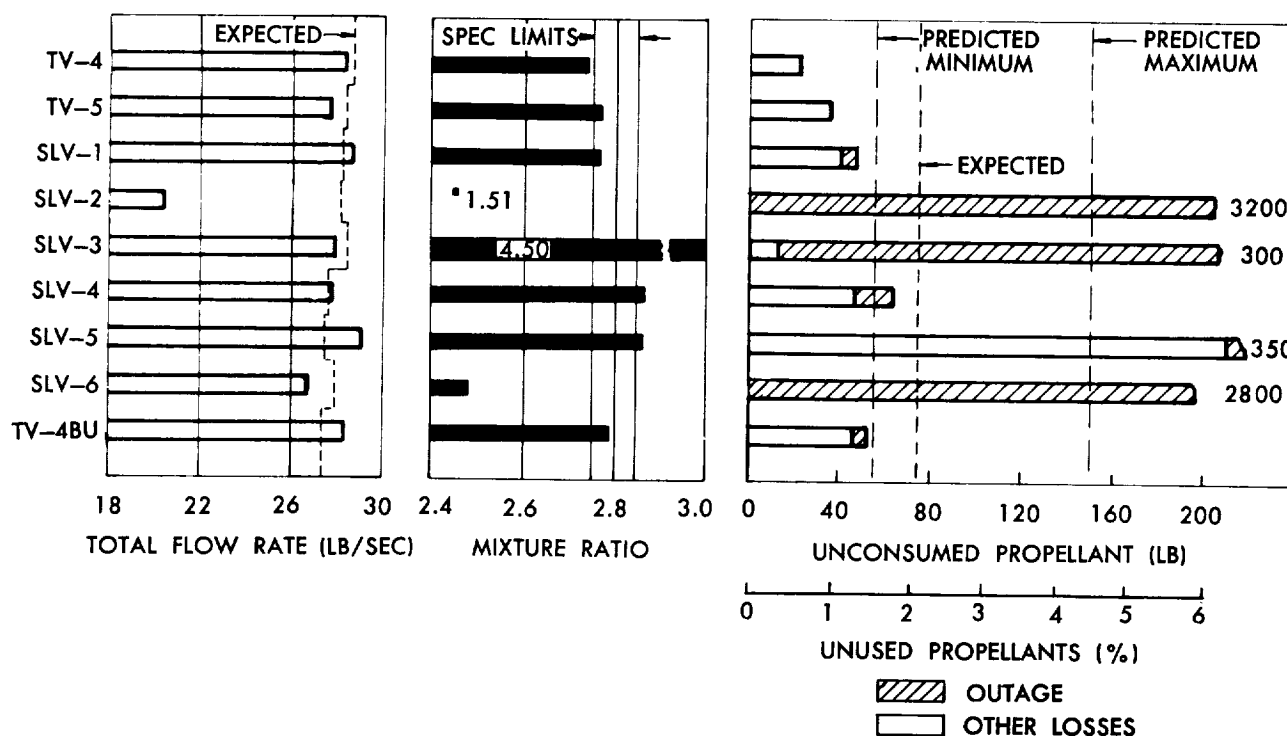
Fig. 59 Second-Stage Propellant Parameters
